GERMAN SELF-PROPELLED GUNS

**Self-propelled artillery
anti-tank and anti-aircraft guns**

Gordon Rottman

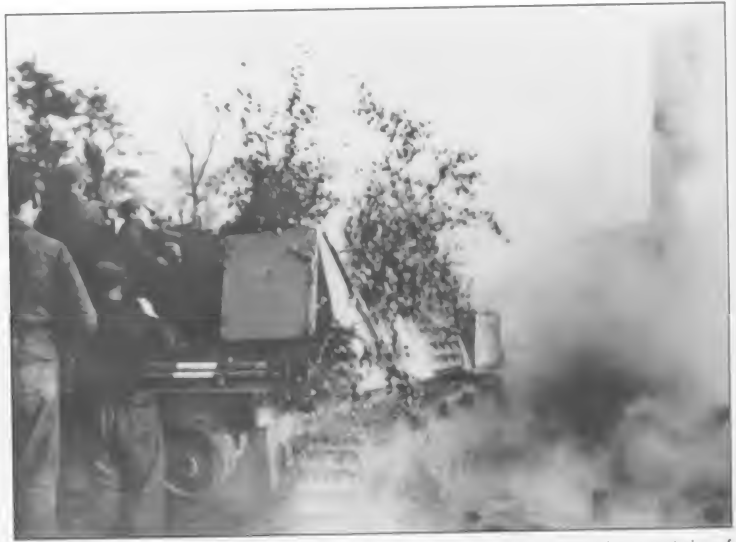
A 'Hummel' fires a 15cm round directly into a Soviet bunker certain of devastating effect. This was a last resort option. Being mounted on a full-tracked tank chassis with an armored well-sloped hull and superstructure coupled with a long barrel gun gives the 'Hummel' and 'Wespe' the appearance of an assault gun or tank destroyer. Their thin armor, high profile, and limited traverse made them extremely poor direct fire combat vehicles. They were intended for indirect fire support.

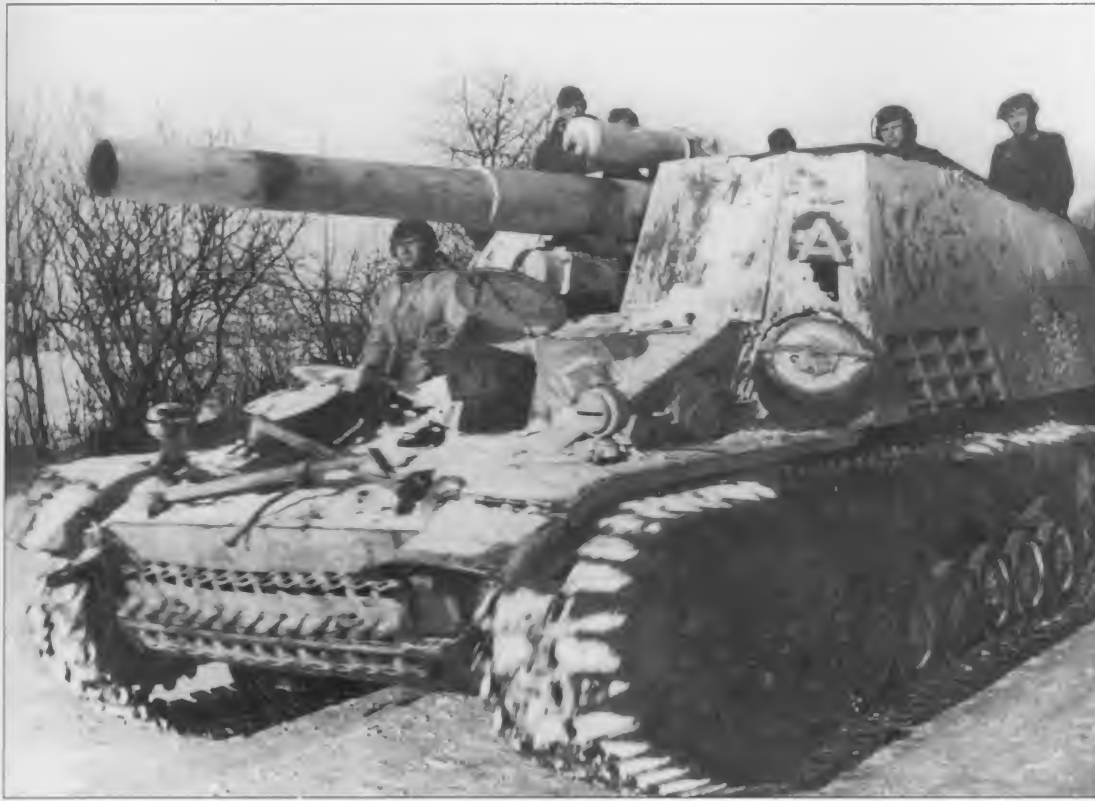
This 'Hummel', Haubitze "A," seen in Russia in January 1944, has been whitewashed. Besides the driver, the radio operator shared the bow compartment. The 'Hummel' had a six-man crew. Note the travel lock bars are folded down in the firing position and are not securing the barrel even though the vehicle is in motion. It has also been fitted with the wider 'Winterkette' tracks.

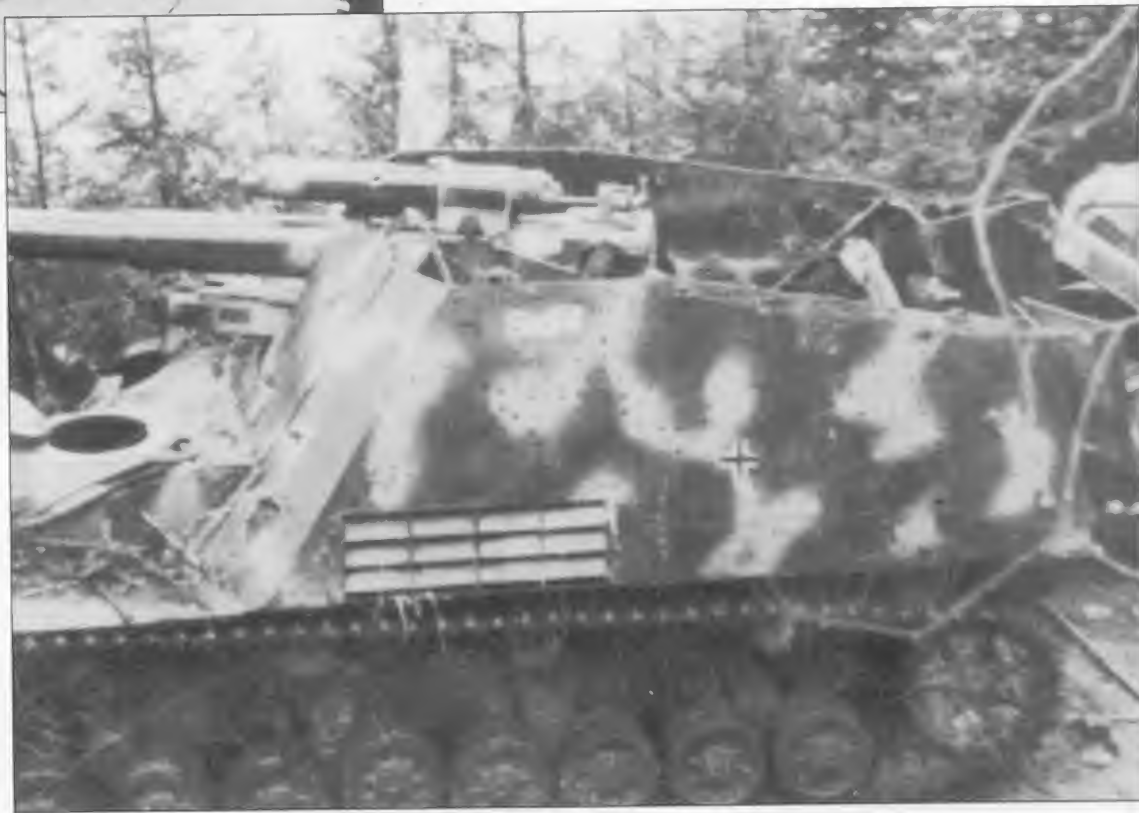
An abandoned 'Hummel' in Austria, 1945. This gun is spray-painted in irregular splotches of olive green and red brown on dark yellow. Dabs of the two darker colors are scattered over the pattern for a more natural effect. The vehicle's name, "Siegfrit," is painted in white on the superstructure's side. A shell fragment hole can be seen in the over-barrel recoil cylinder.

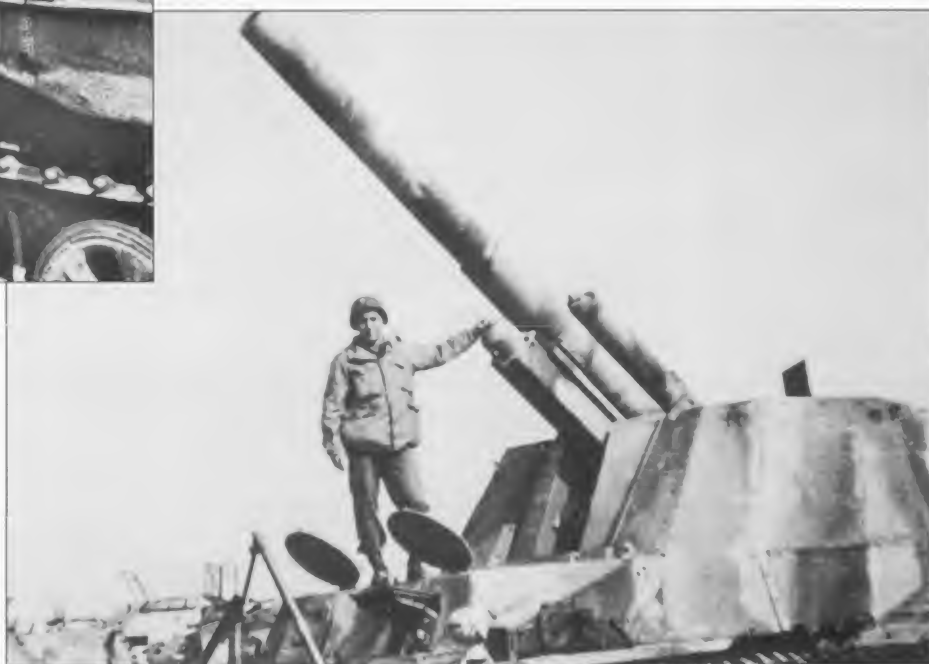
The 15cm s.F.K.18/1 L/30 heavy field howitzer of the 'Hummel' was the same weapon as used on the towed version. Ammunition included: high explosive, armor-piercing, concrete-piercing, and smoke. Elevation was 42 degrees and traverse was 15 degrees right and left. A louvered cover ventilated the engine, but many were additionally fitted with an angled shield opening upward. This can be seen in the lower right of the photograph. Czechoslovakia, May 1945.

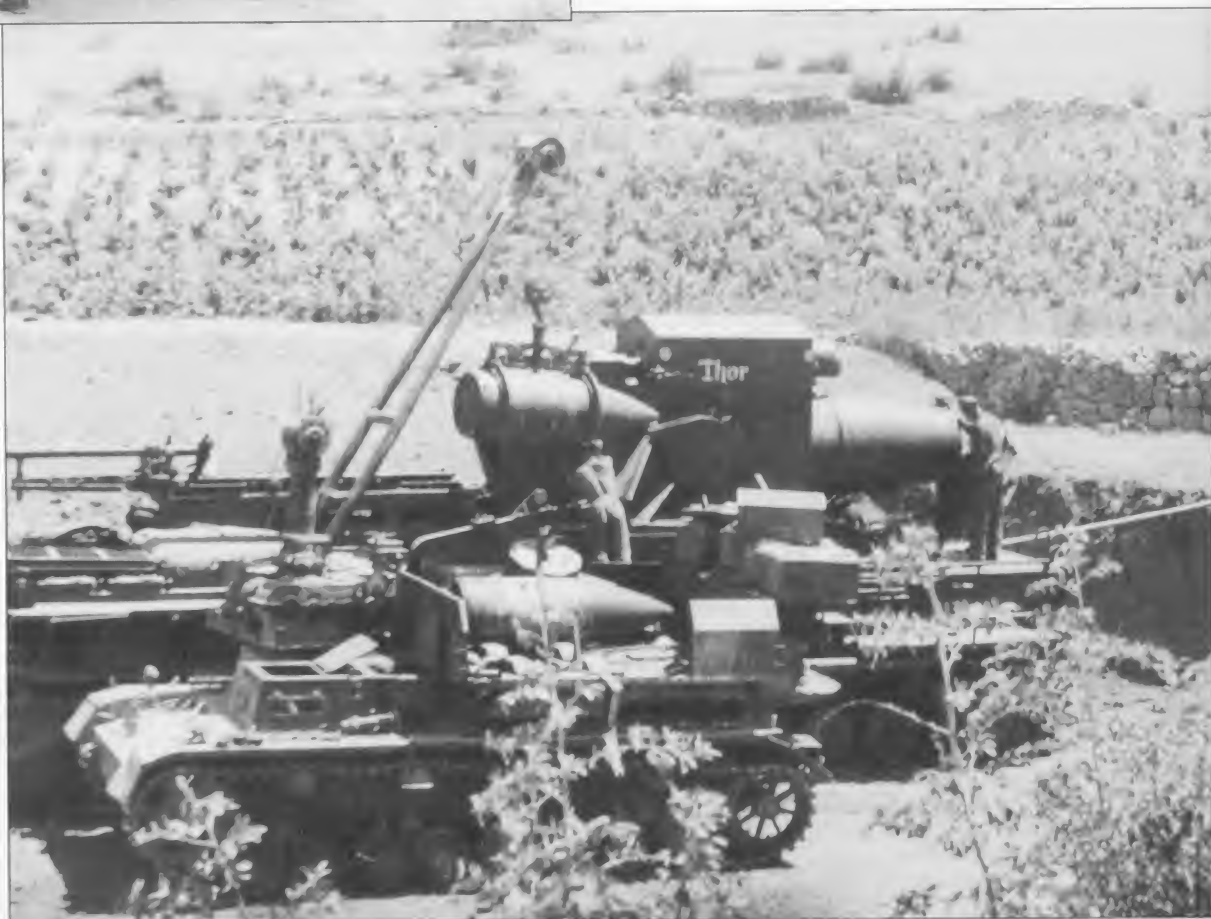
The Karl-Gerät 040 was fitted with an enormous 60cm howitzer making it the largest caliber gun mounted on a fully tracked chassis. Six of these huge guns were built from November 1940 to August 1941. Here we see gun number IV, named 'Thor', having a 2.17-tonne 60cm schwere Betongranate 40 (concrete piercing) shell being swung over onto its loading tray by an accompanying Munitionsschlepper based on the chassis of a Pz.Kpfw.IV Ausf.E. 'Thor' was later fitted with a longer but smaller diameter 54cm barrel as were two other guns. In this configuration, it was known as Karl-Gerät 041.

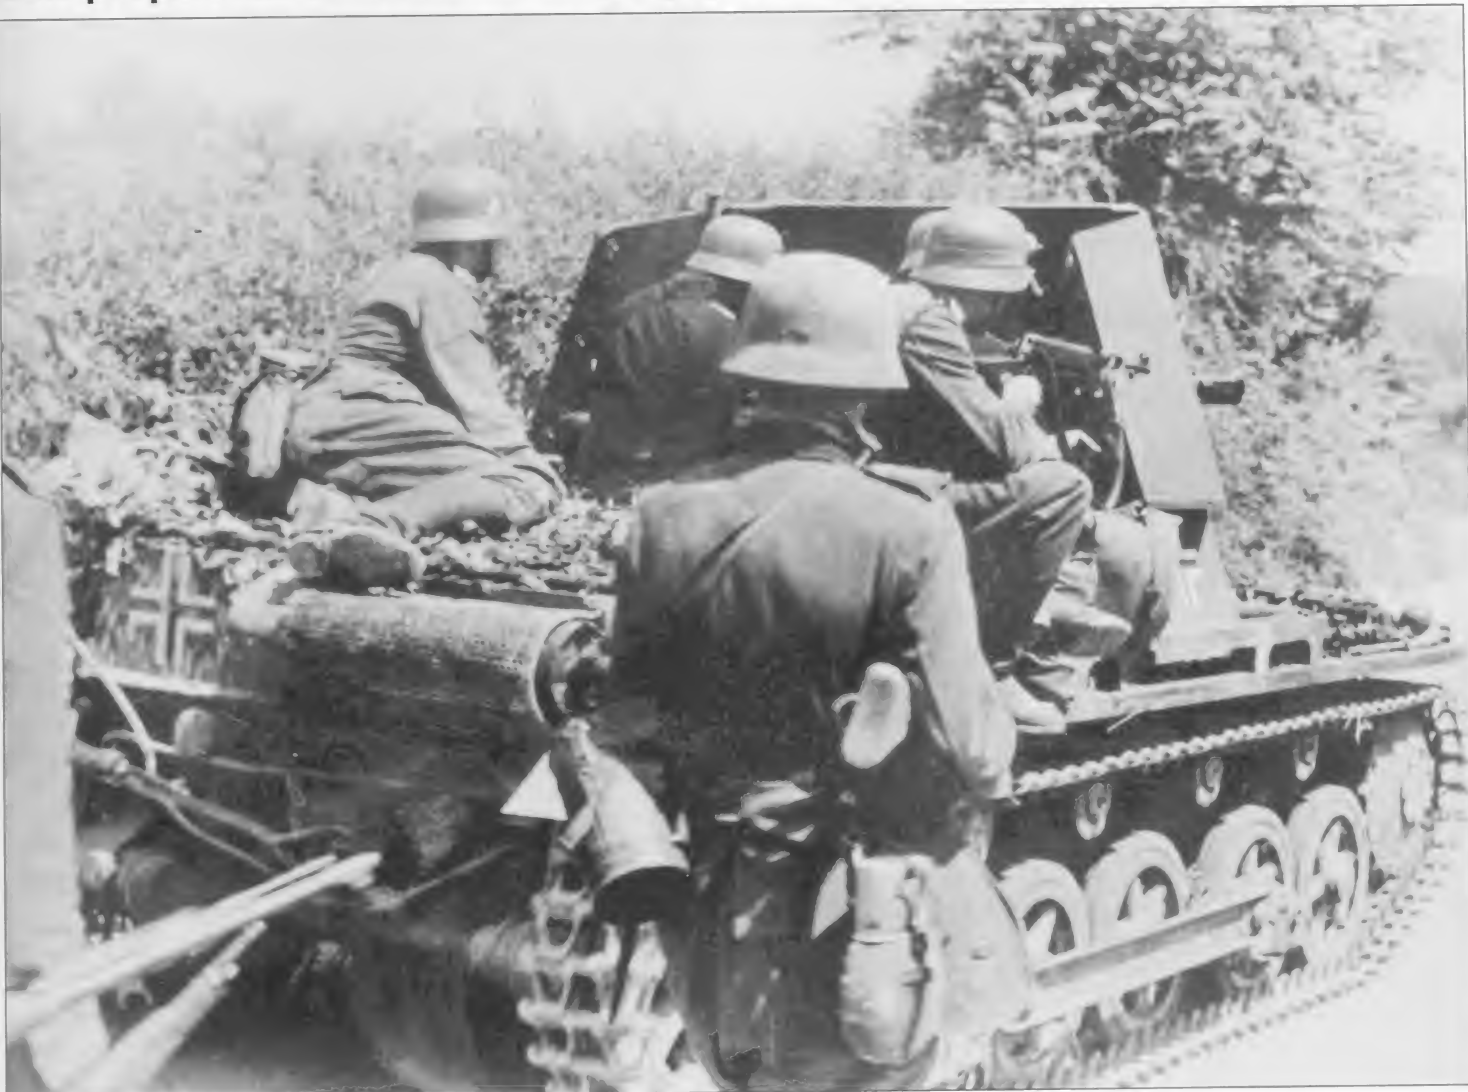
The earliest attempt at a self-propelled antitank gun was the 4.7cm PaK(t) (Sf.) auf Pz.Kpfw.I Ausf.B, or simply, the Panzerjäger I (Sd.Kfz.101). The original concept was for it to mount the 5cm PaK 38, but it was not yet available and a self-propelled antitank gun was essential. Czechoslovak Skoda 47mm KPUV vz.38 Model A5 guns were installed. Designated by the Germans as the 4.7cm PaK 36(t) L/43.4, it proved to be inadequate owing to its comparatively low velocity. Here infantrymen use a Panzerjäger I as cover as they advance down a French road, 1940. This one possesses the Alkett five-sided superstructure. The MP-38 machine pistol-armed group (squad) leader sits on the right track guard and the platoon leader is on the left. One the Panzerjäger crewmen can be seen between the two hitchhikers in his black panzer uniform.

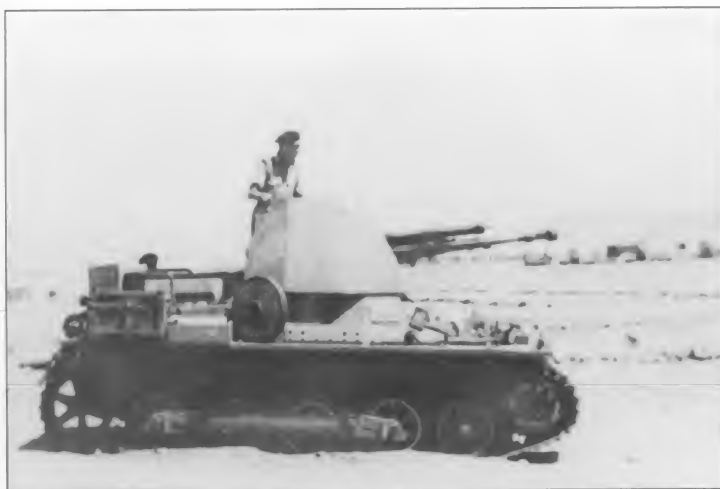
A British soldier in North Africa examines an abandoned Panzerjäger I. This one is a late production vehicle identifiable by its seven-sided superstructure. Ten late versions were built by Alkett and the remaining sixty were built by Kloeckner-Humboldt-Deutz. The gun compartment was cramped for the three-man crew and was open to the top and rear. It carried 86 rounds of ammunition. Because of the confined gun compartment and the vehicle's small size, crew typically strapped on numerous boxes and creates for tools, spare parts, and equipment. Many vehicles arriving in North Africa still bore their continental dark gray finish. Crews sprayed oil on their vehicles and flung on sand. Once baked beneath the desert sun it adhered rather well.

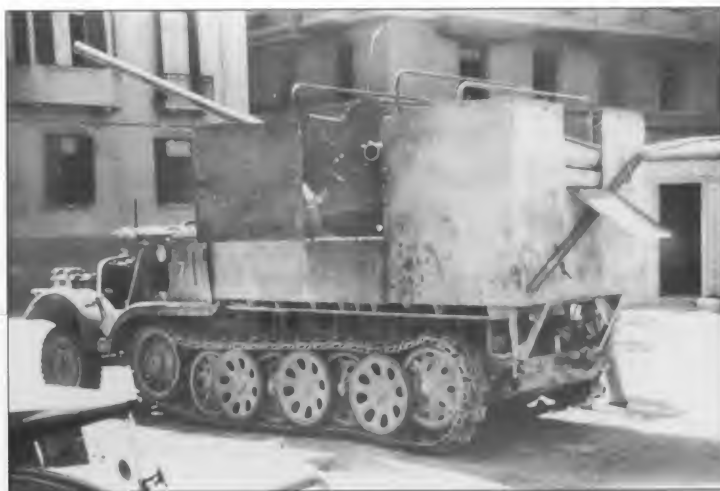
In an effort to provide much needed mobile antitank guns nine Soviet 76.2mm field guns were mounted on 5-ton Sd.Kfz.6 halftracks in 1941. The 7.62cm PaK 36(r) auf Panzerjäger Selbstfahrlafette 'Diana' had a crew of five. The 10mm armored housing protected the crew from light fragmentation and little else. A crew access door is in either side of the high profile housing. The rear drop-hatch allowed empty cartridge cases to be ejected. The front was mostly open, but the gun's original shield was retained. It had a 30-degree traverse left and right. 64 rounds could be carried. Six were built and all served with Pz.Jg.Abt.605 in North Africa.

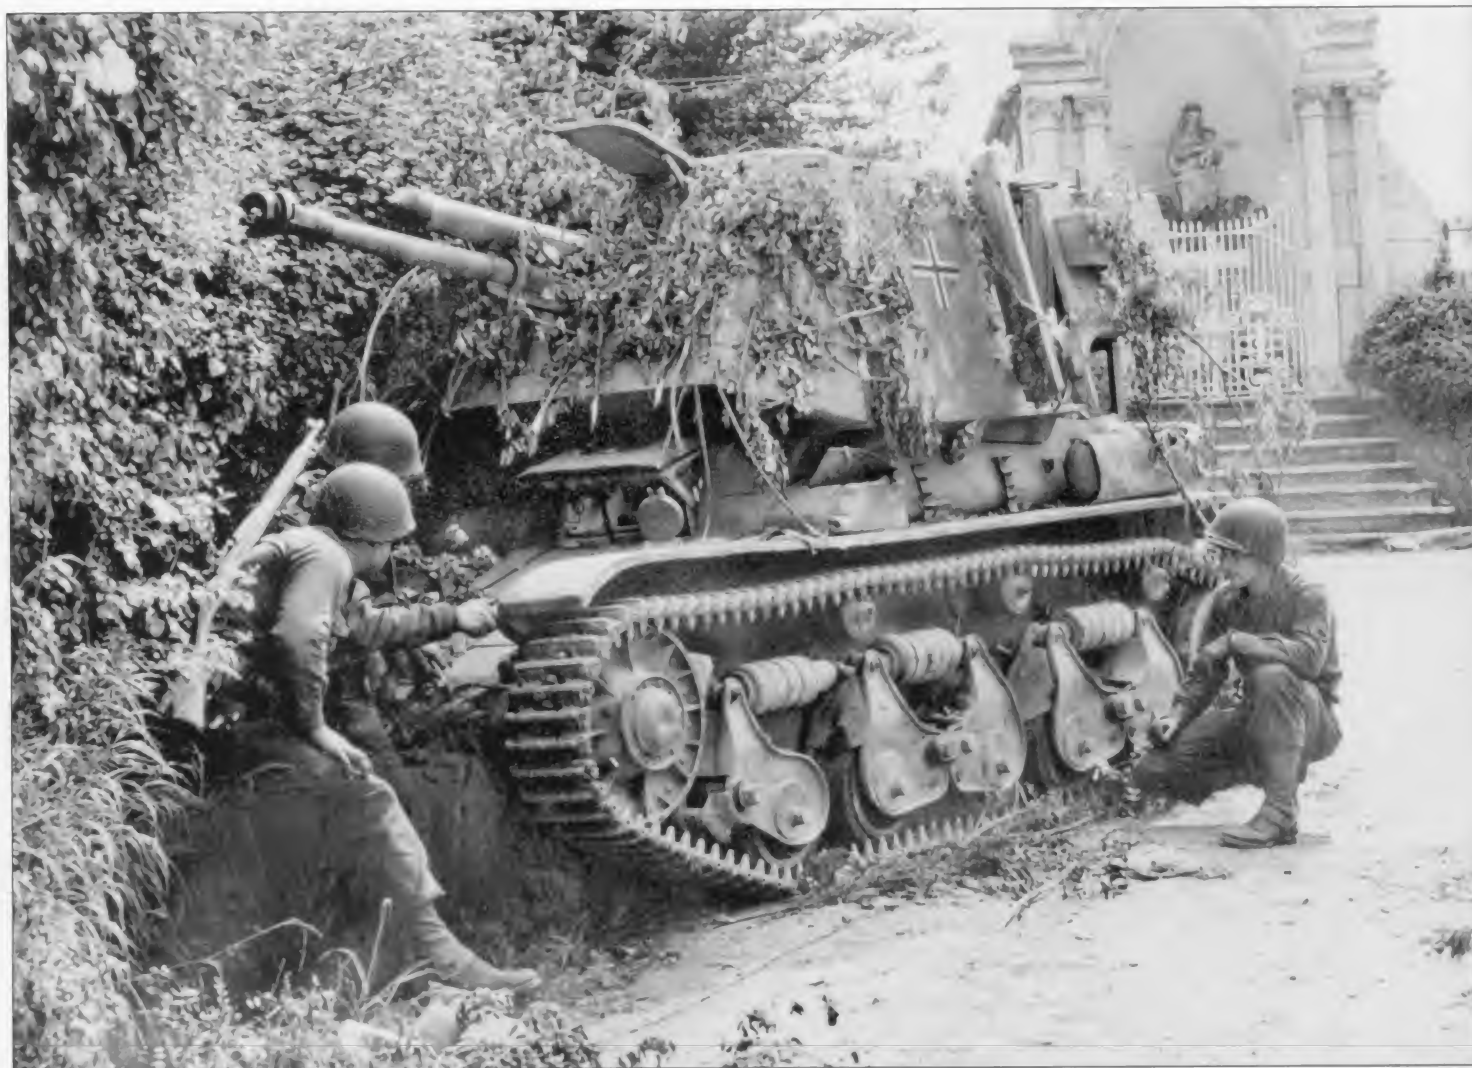
American soldiers inspect an abandoned 4.7cm PaK(t) auf Pz.Kpfw.35R(f) in France, 1944. The turret was removed from a French Renault R35 light tank and replaced by a non-rotating superstructure mounting a Czechoslovak 47mm KPUV vz.38 antitank gun. The superstructure was open-topped and included a large storage compartment to the rear with space between the overhanging compartment and the engine venting. Besides the unusual overhanging compartment the superstructure was fitted with escape hatches on both sides, one of which is open in the photograph.

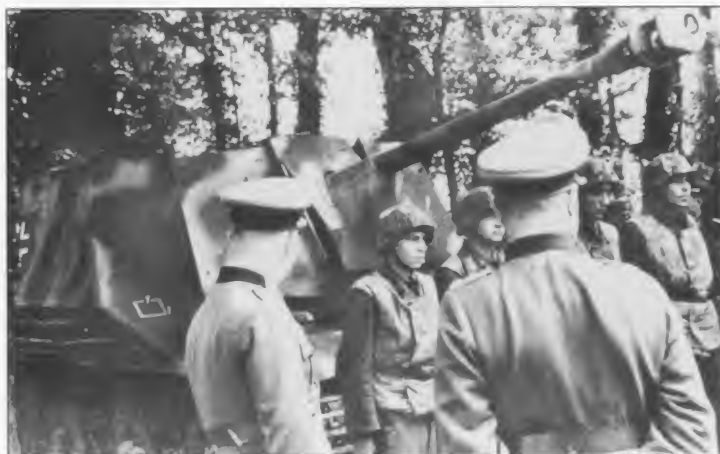
The 7.5cm PaK 40/2 auf Fahrgestell Pz.Kpfw.II (Sf.) Marder II (Sd.Kfz.131) made effective use of the large numbers of obsolete Pz.Kpfw.II Ausf.F light tank chassis. 37 main gun rounds were carried. An MG-34 was carried inside the gun compartment. The gun compartment had an open top and a partly open back. There was sufficient cover provided by the high engine deck to allow the crew to duck down inside. A canvas cover provided the gun compartment with weather protection. This was removed in combat. 5-30mm armor protected the three-man crew. The brackets on the superstructure's side held picks and shovels. The crewman cleaning the headlight is wearing the off-white drill uniform worn when conducting vehicle maintenance.

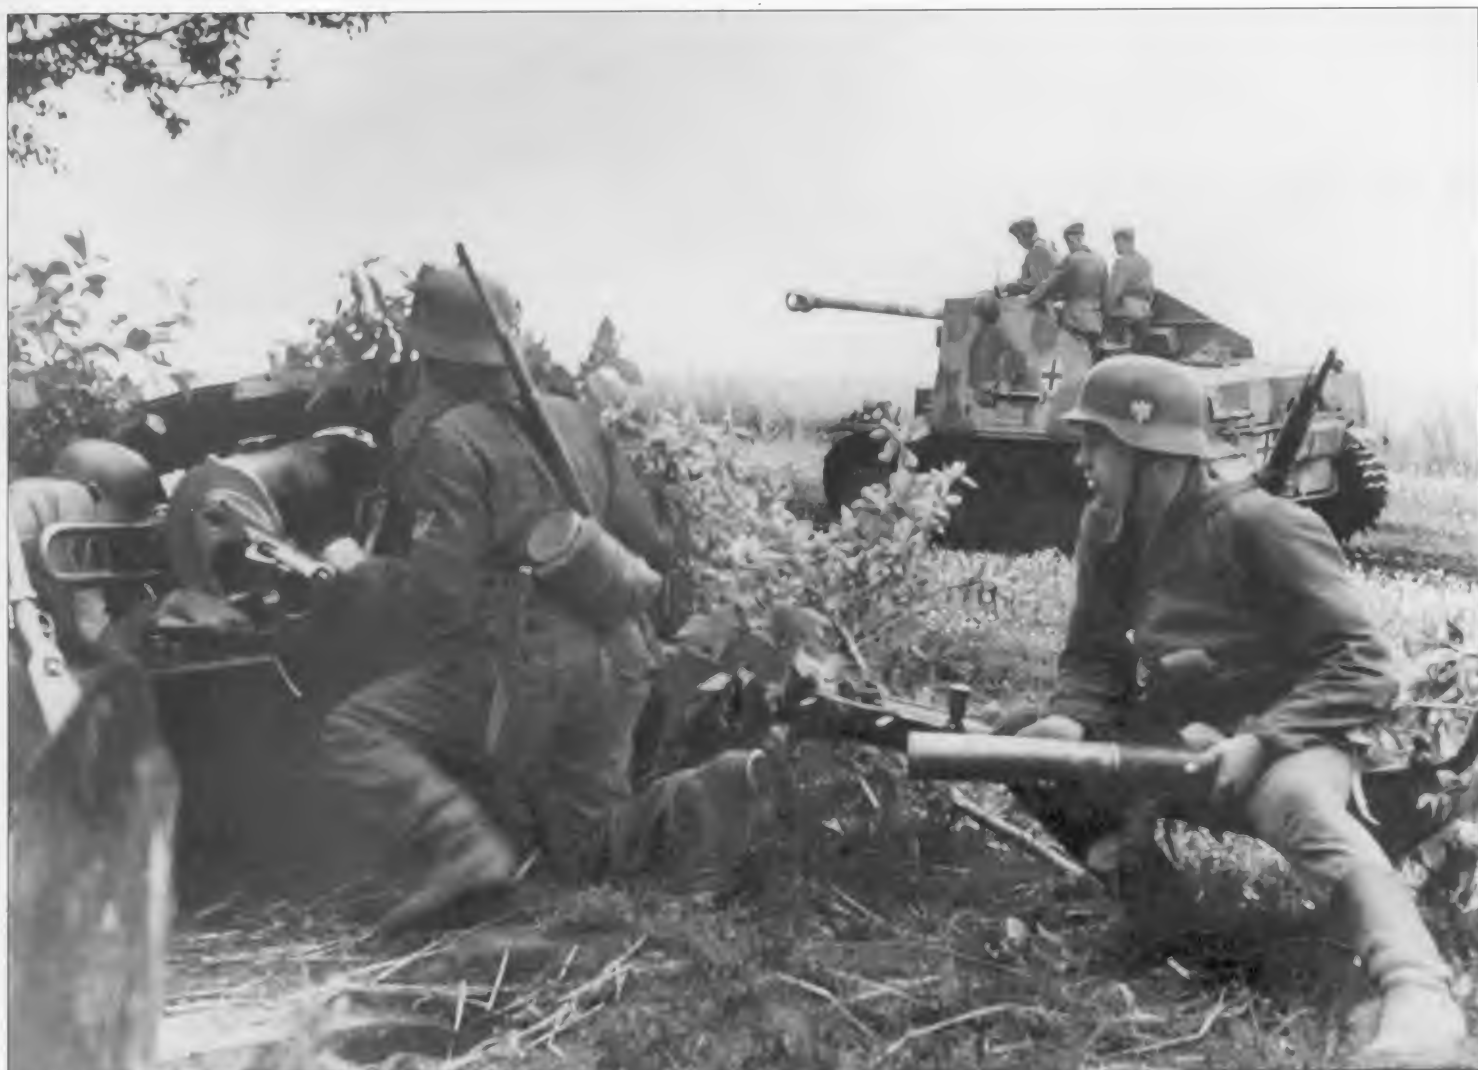
A Marder II (Sd.Kfz. 131) passes the crew of a 7.5cm PaK 97/38 antitank gun. This was a French 75mm M1897 field gun barrel mounted on a German 5cm PaK 38 carriage for emergency use after the widespread appearance of the T-34 tank. They used French and Polish armor-piercing ammunition as well as German-produced hollow-charge rounds. Antitank crewmen were expected to keep their carbines slung because of the necessary for extremely rapid gun displacement. The Marder is painted with large irregular spots of dark green on its dark yellow base, far too contrasting with the green spots' sharply defined edges to be fully effective. This view of the Marder demonstrates just how exposed the crew was to the rear to artillery and mortar bursts.

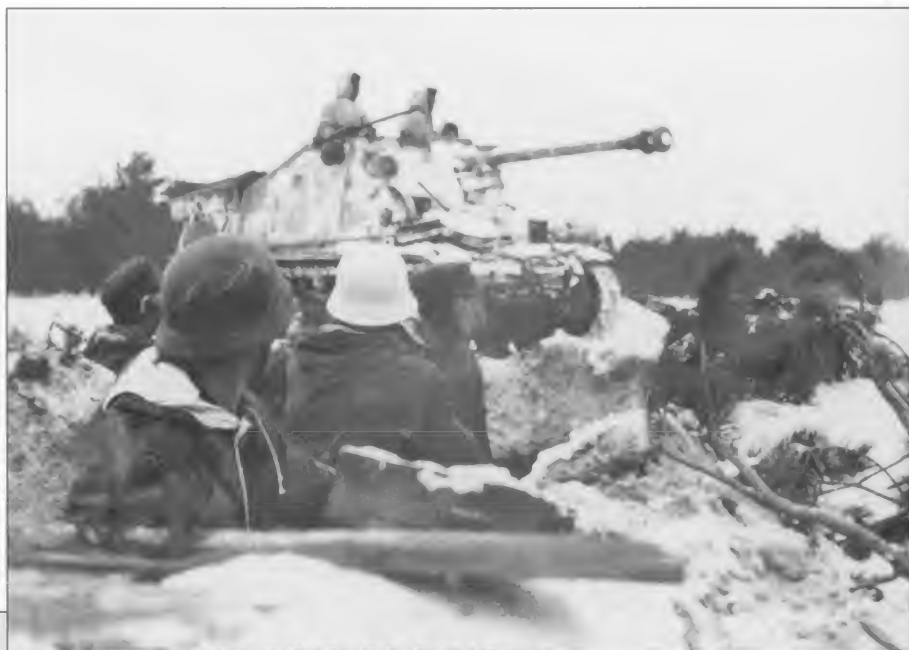
This Marder II (Sd.Kfz.131) is backed into woods for concealment. Track sections and spare road wheels are fastened to the hull. The half-dozen white bands on the barrel are kill rings (Abschussringe) indicating the number of enemy vehicles this gun had destroyed. The crudely painted white tactical number is too obscured to make out. An MG-34 can be seen at the top right of the superstructure. The crew wears the insulated winter uniform with the camouflage side out.

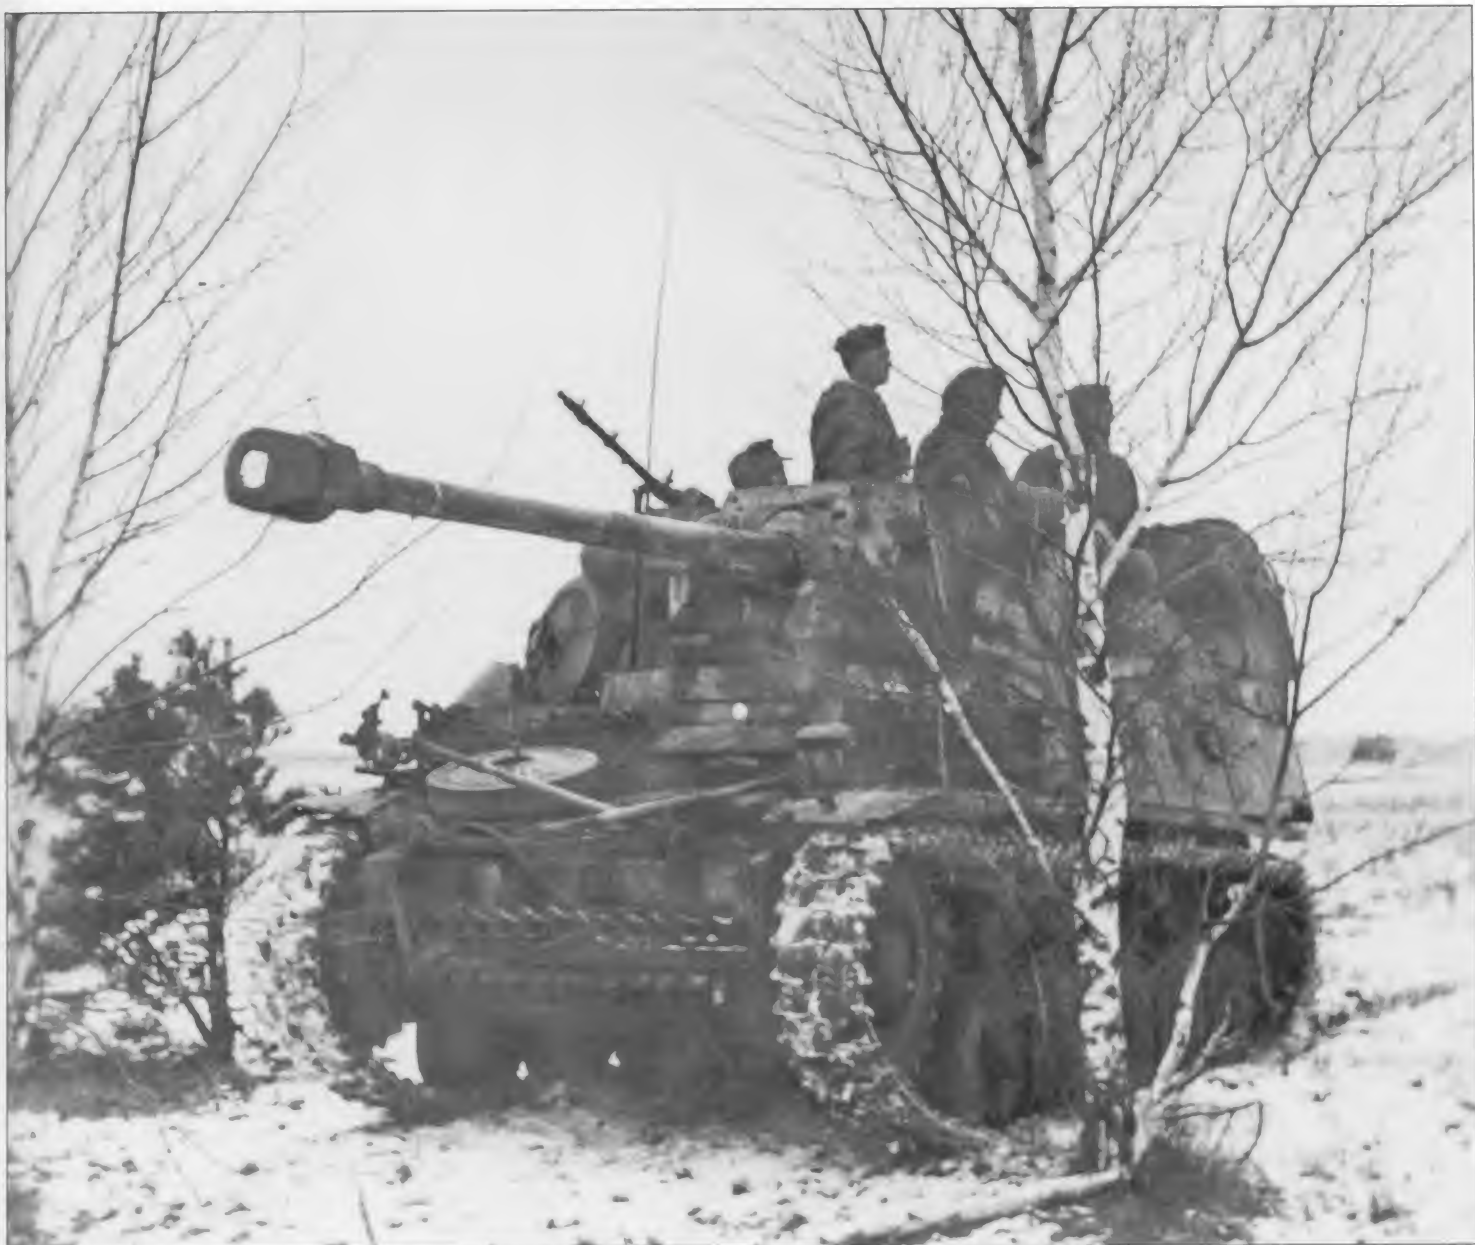
Several Marder II's in winter. It was common practice to secure spare road wheels and track sections to the front. Note that all mount an MG-34 on the right front of the gun compartment indicating their value as anti-personnel weapons. One (hull number 113) has its machine gun protected by a canvas cover. Most of these appear to be early winter, as whitewash has not been applied. The camouflage paint scheme may be red brown and olive green leaving little of the dark yellow base visible. The hull numbers (113, 122) are white.

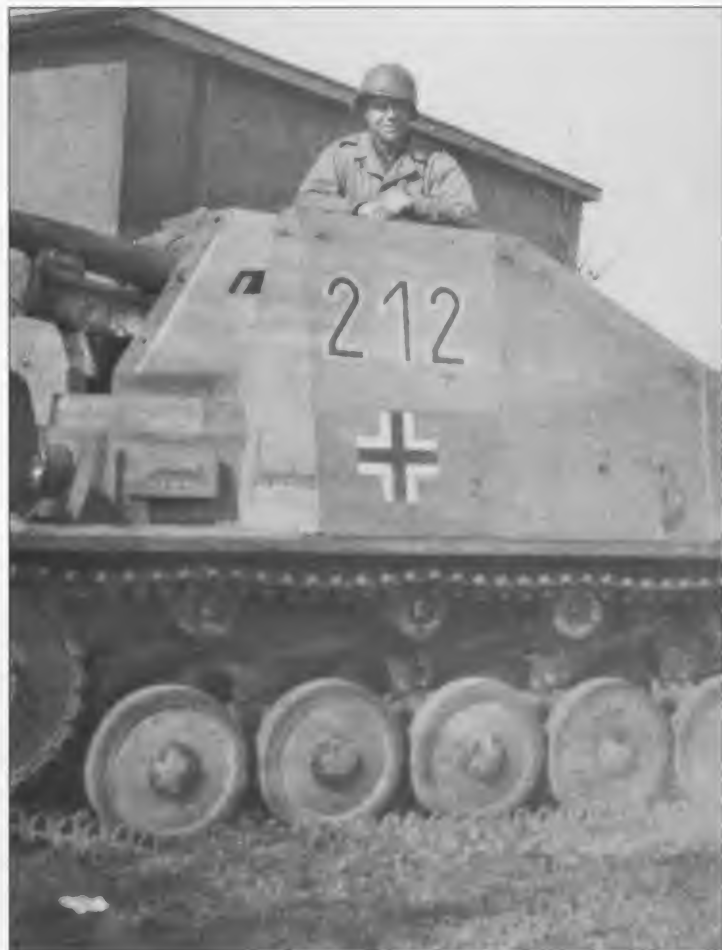
The Panzer Selbstfahrlafette 1 für 7.62cm PaK 36(r) auf Fahrgestell Pz.Kpfw.II Ausf.D1 und D2 (Sd.Kfz.132), while still designated the Marder II, was of a much different design than the Sd.Kfz.131. For all practical purposes it was an entirely different vehicle being built on Pz.Kpfw.II Ausf.D chassis and mounting former Soviet 76.2mm F-22 (M-1936) divisional field gun and designated the 7.62cm PaK 36(r) L/51.5 by the Germans. While primarily a field gun in Soviet service, it was designed to be an effective antitank gun as well. Some were rechambered for German 7.5cm PaK 40 ammunition and the muzzle brake removed. The vehicle had a rather high profile and the four-man crew was exposed even though the gun shield was fitted with side extensions. The Ausf.D1 were converted from Pz.Kpfw.II Ausf.D and E chassis while the Ausf.D2 was built on a Flammpanzer Pz.Kpfw.II(F) (Sd.Kfz.122) flamethrower tank chassis. The crew of this Marder II in Russia, September 1942, wear the black panzer uniform. 20-liter cans hang on the front superstructure. Not exactly a safe practice, but they may be filled with water, through water cans normally had large white crosses on the sides.

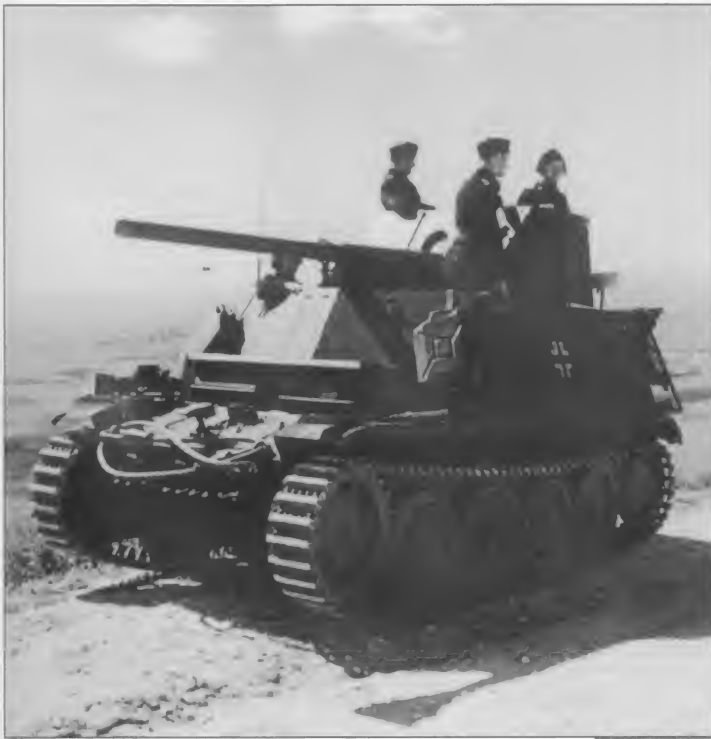
Another view of the same Marder II (Sd.Kfz.132). Rather than integrating the gun mounting into the superstructure, as on most other Marders, the gun was set atop the superstructure giving it a wider 50 degrees left and right traverse. Armor was 5-30mm. Thirty rounds of ammunition were stowed and an MG-34 was carried inside the gun compartment. While no machine gun mounting was provided on the vehicle as on most other self-propelled antitank guns, they could be fired handheld or dismounted for close-in defense such as when in a night lager.

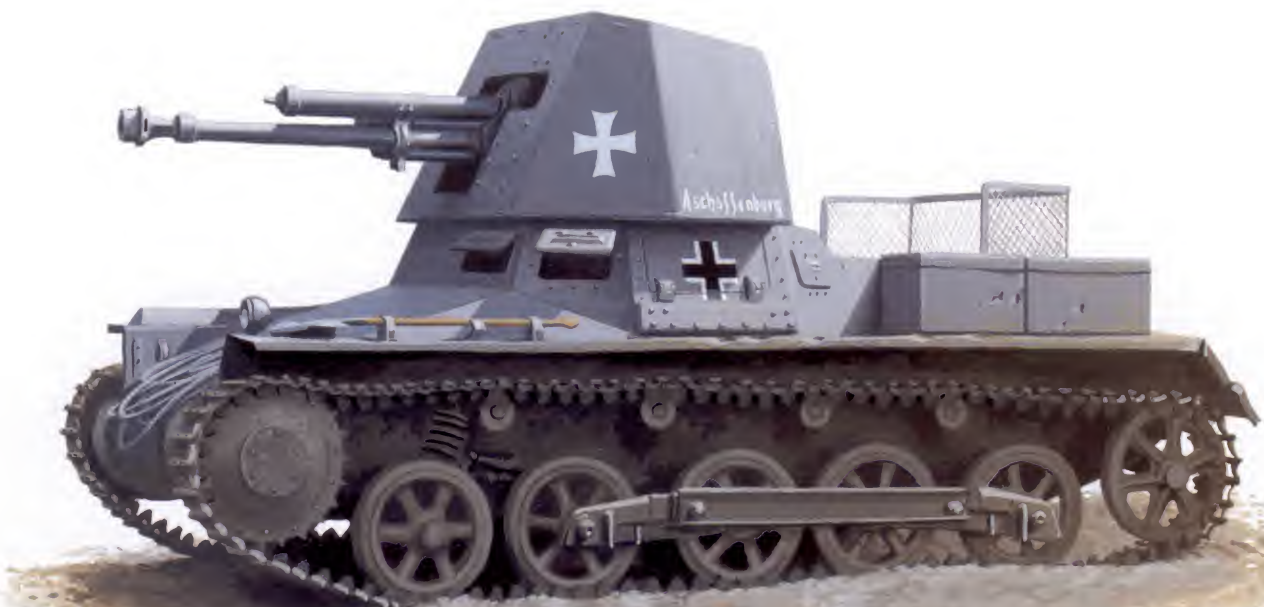
4.7cm PaK 36(t) (Sf.) auf Pz.Kpfw.I Ausf.B (Sd.Kfz.101) or Panzerjäger I, Panzerjäger-Abteilung 643, France, 1940

The white Maltese cross was a unit insignia and was painted on both sides of the superstructure and on the hinged left rear fender. "Aschaffenburg" is the name of the city that the unit's home garrison was located in. From 1940 to early 1943 most armored fighting vehicles were painted dark gray (RAL 7021).

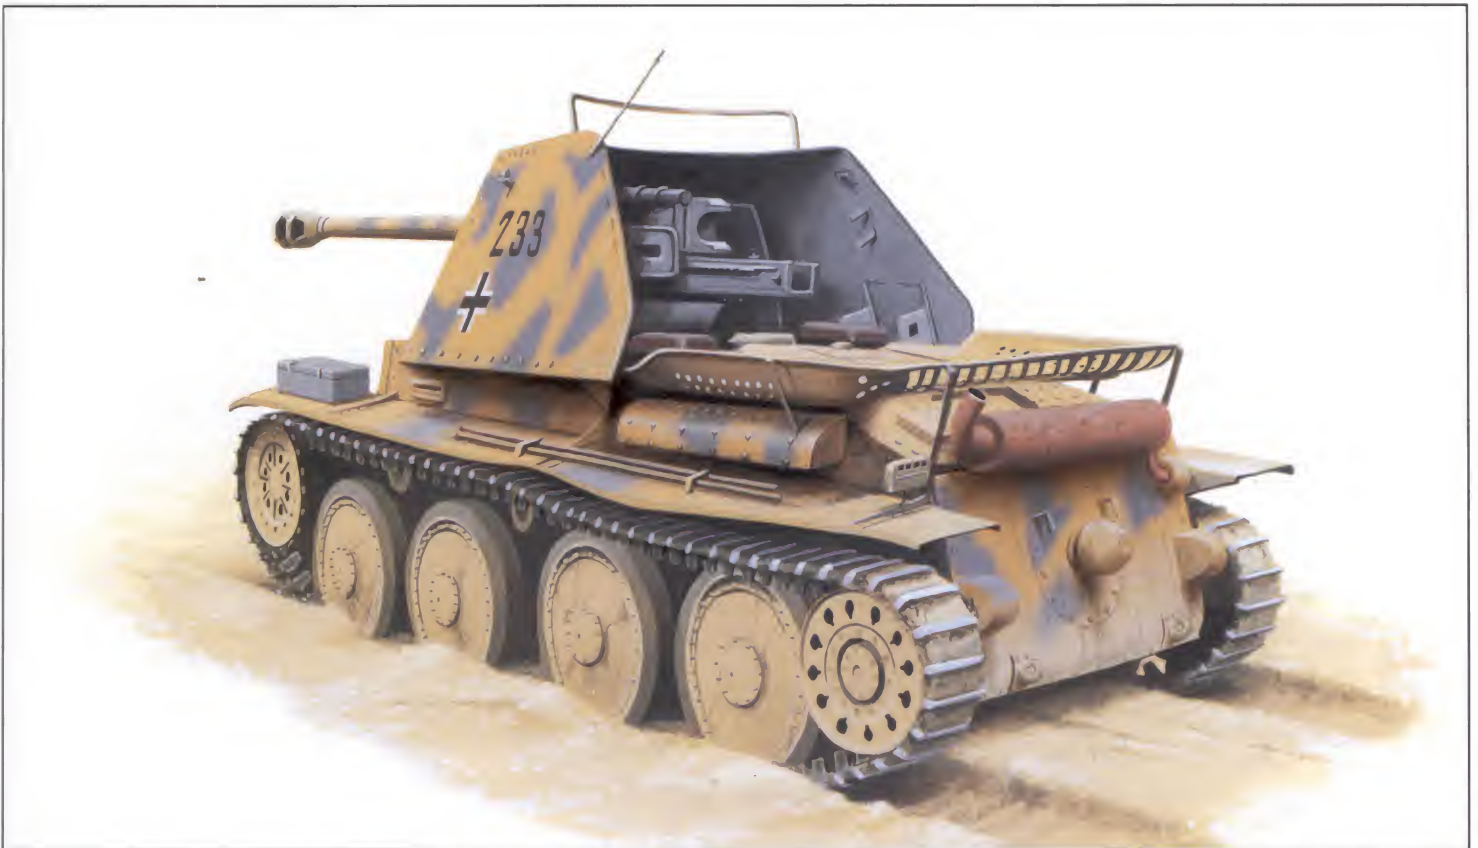
Panzerjäger mit 7.5cm PaK 40/3 auf Pz.Kpfw.38(t) Ausf.H (Sd.Kfz.138), or Marder III, 2./Panzerjäger-Abteilung 39, 21.Panzer-Division, Tunisia, March 1943

The European dark gray (RAL 7021) was over-sprayed with sand yellow (RAL 8000) leaving irregular gray spots of the base coat. The interior was left gray. The vehicle's tactical number identifies it as 2nd Company, 3rd Platoon, Number 3 gun.

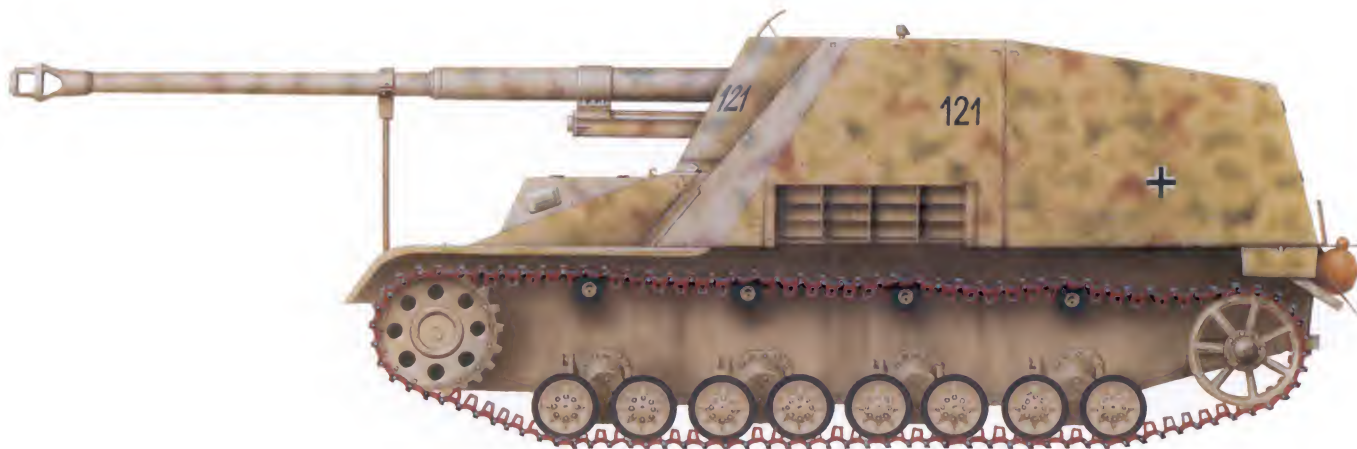
8.8cm PaK 43 auf Fahrgestell Pz.Kpfw.III und IV (Sd.Kfz.164), or Nashorn, schwere Heeres-Panzerjäger-Abteilung 525, Italy, 1944

Small splotches of olive green (RAL 6003) and red brown (RAL 8017) have been sprayed over the dark yellow (RAL 7028) base coat. The black tactical number of the sides and left shield identifies this vehicle as 1st Company, 2nd Platoon, Number 1 gun.

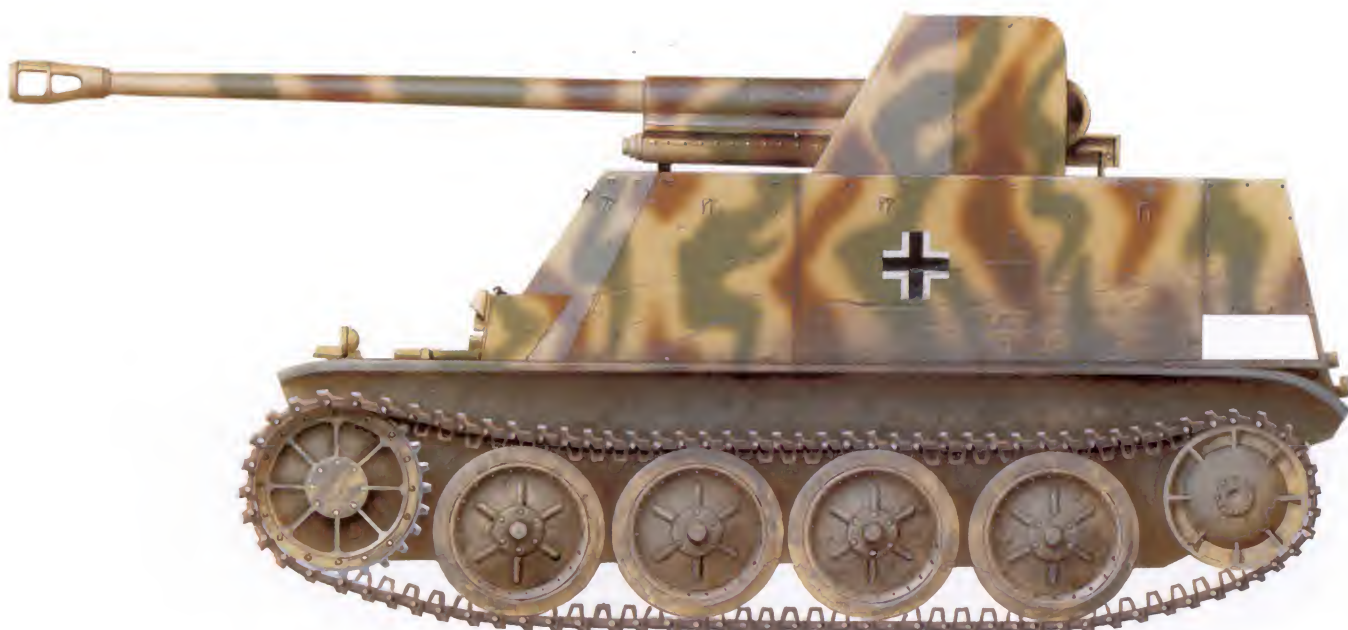
Panzer Selbstfahrlafette 1 für 7.62cm PaK 36(r) auf Fahrgestell Pz.Kpfw.II Ausf.D (Sd.Kfz.132), or Marder II, 5.SS-Panzer-Division "Wiking," Poland, 1944

From early 1943, armored fighting vehicles were factory-painted a dark yellow (RAL 7028) base color over which one or two other colors could be applied by the unit appropriate for the vegetation and terrain they were operating in a suitable camouflage pattern. The most commonly applied colors were dark olive green (RAL 6003) and red brown (RAL 8017). A common alternate color was olive green (RAL 8002). A standard white outlines black Balkenkreuz is painted on each side of the superstructure.

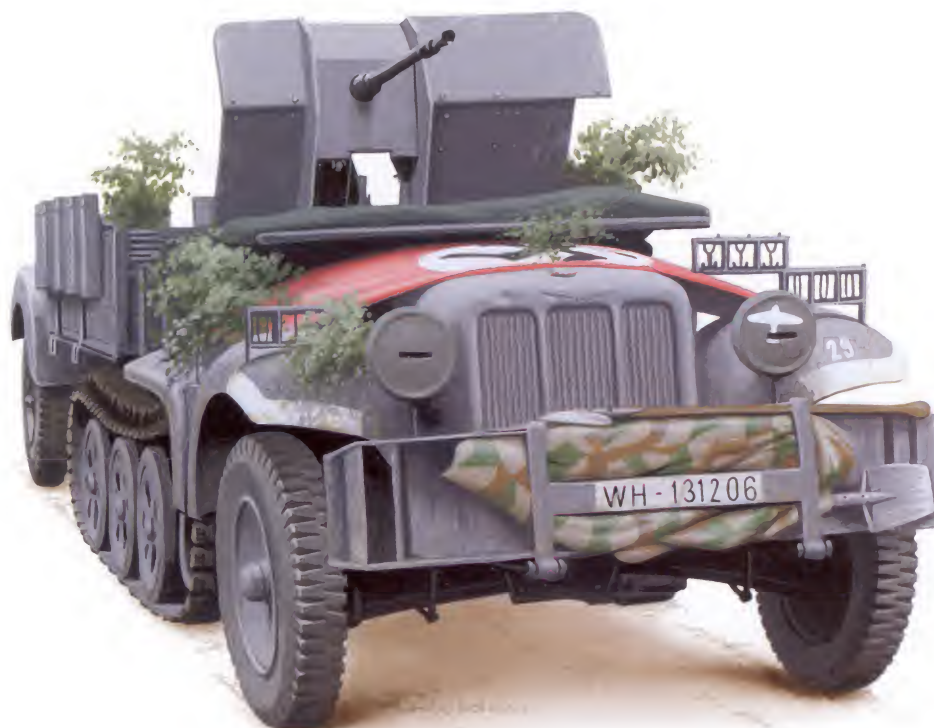
Sd.Kfz.10/4 halftrack mounting a 2cm FlaK 30, Fliegerabwehr-Bataillon 46, 29.Infanterie-Division (mot.), France, 1940

The halftrack and its ammunition trailer are dark gray (RAL 7021). The white edging on the front fenders was a common peacetime and early wartime means of making the vehicles more visible at night for safety reasons. The aircraft silhouette on the headlight's blackout cover indicates the number of kills. A national flag has been secured to the hood as an air recognition means for aircraft.

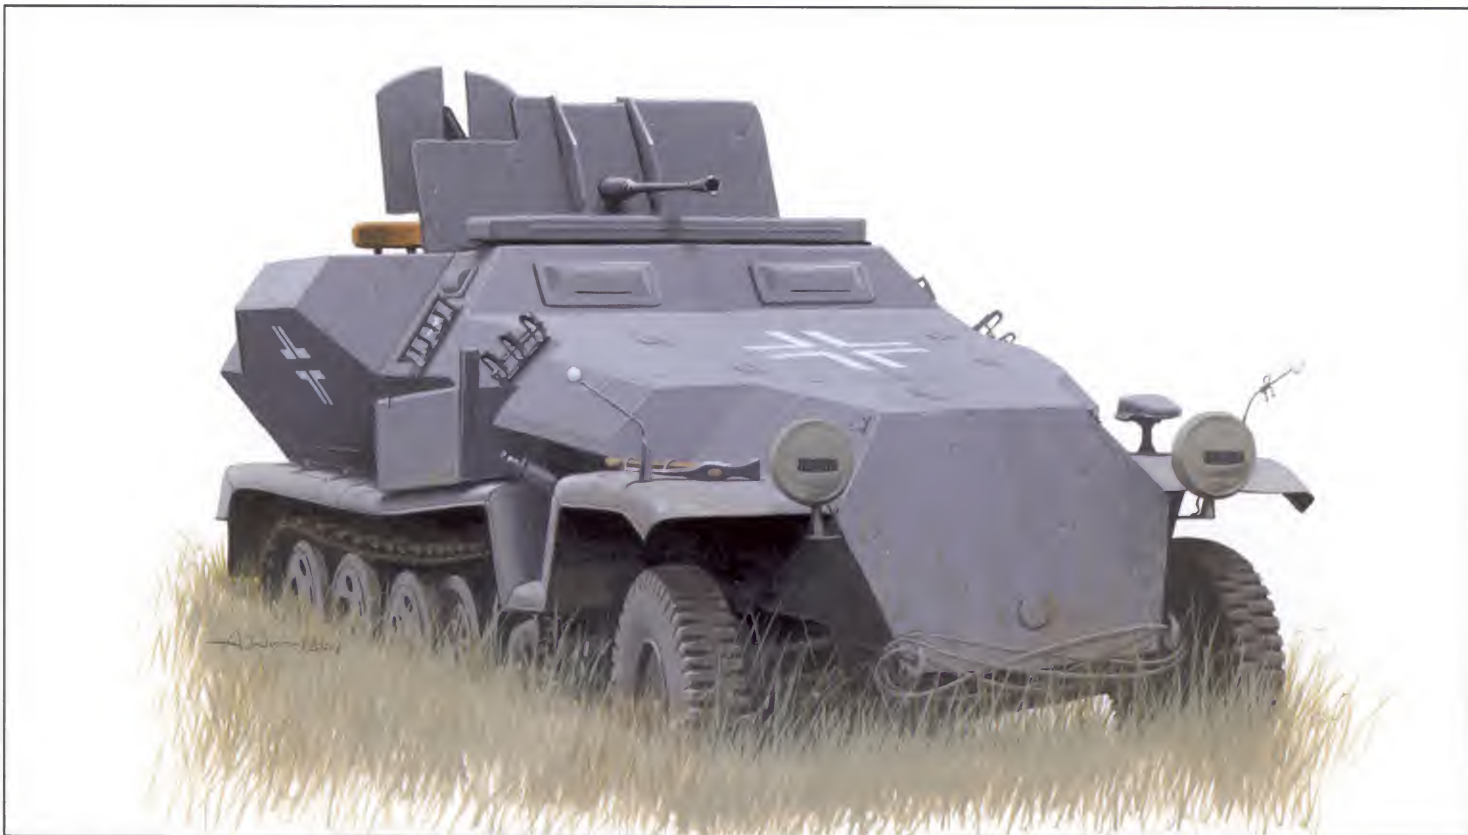
Sd.Kfz.251/17 Ausf.C, FlaK-Regiment "Hermann Göring," 1942

In 1942, 10 of these experimental half-tracks were built for the Luftwaffe on a modified Sd.Kfz.251 Ausf.C chassis and a 2cm Flak 38 installed on a raised platform inside the vehicle. The sides could be lowered for more working space, but the weapon could be operated with the sides raised. However, it was too complex and expensive and no further vehicles were produced. The flat box on the roof above the driver contains spare barrels. It is painted dark gray (RAL 7021) with a white-outlined Balkenkreuz.
